## AGARD ADVISORY REPORT 308

### Propulsion and Energetics Panel Working Group 20

### Test Cases for Engine Life Assessment Technology

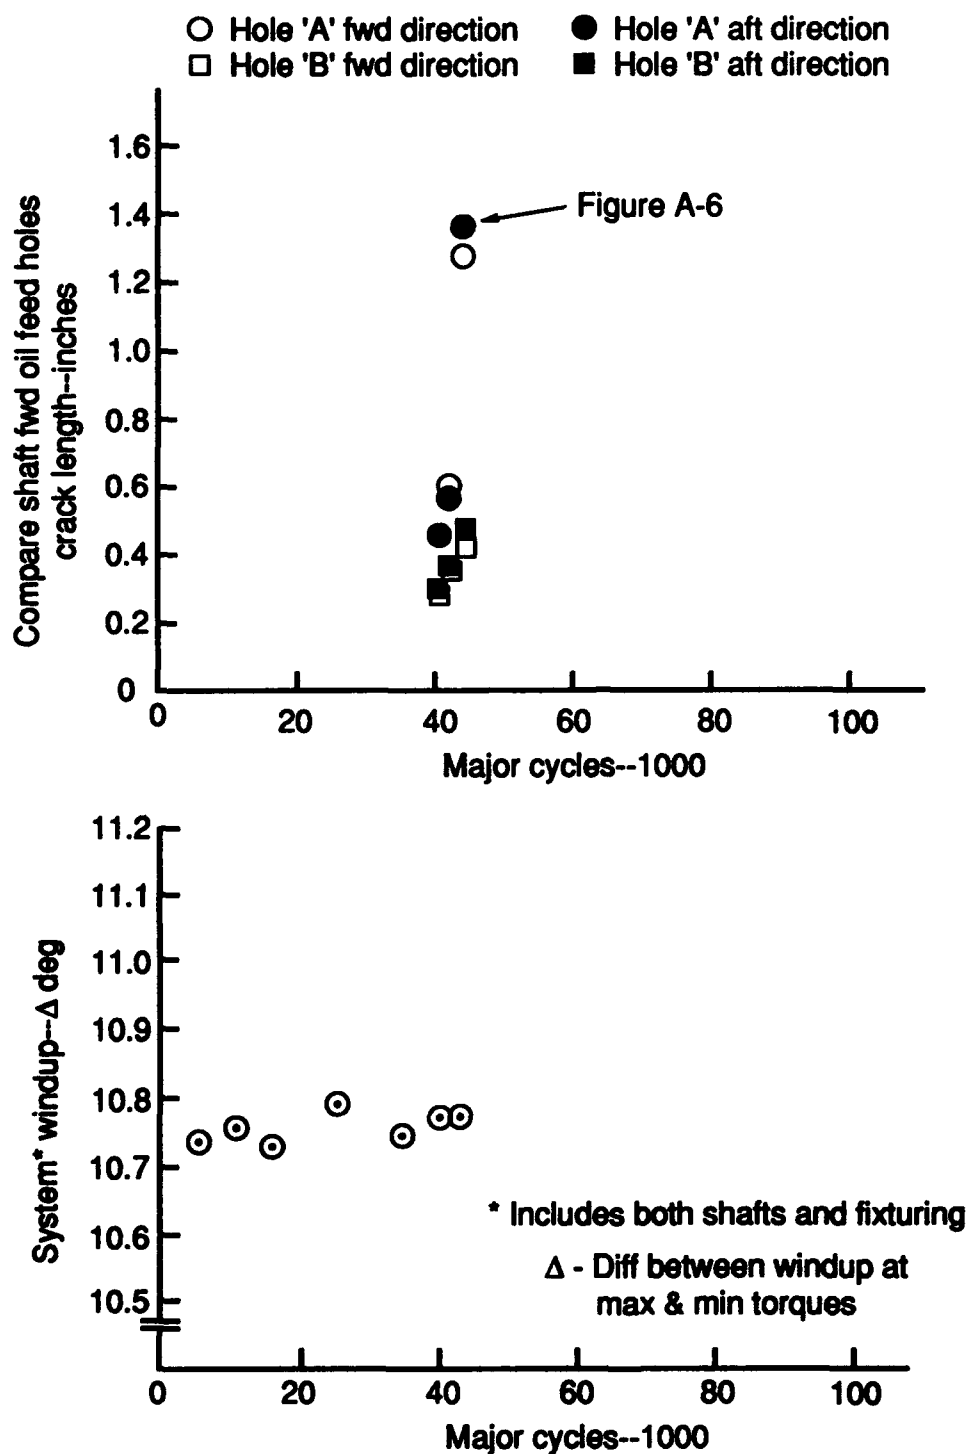
Fig. A-7. TF41 LP mainshaft LCF torsion (TC 875)—compressor shaft 6860005, DP 10356, N.B., 3410 hr; turbine shaft EX 142055, KK12846, B.B., 0 hr, XA18268, BU 5.

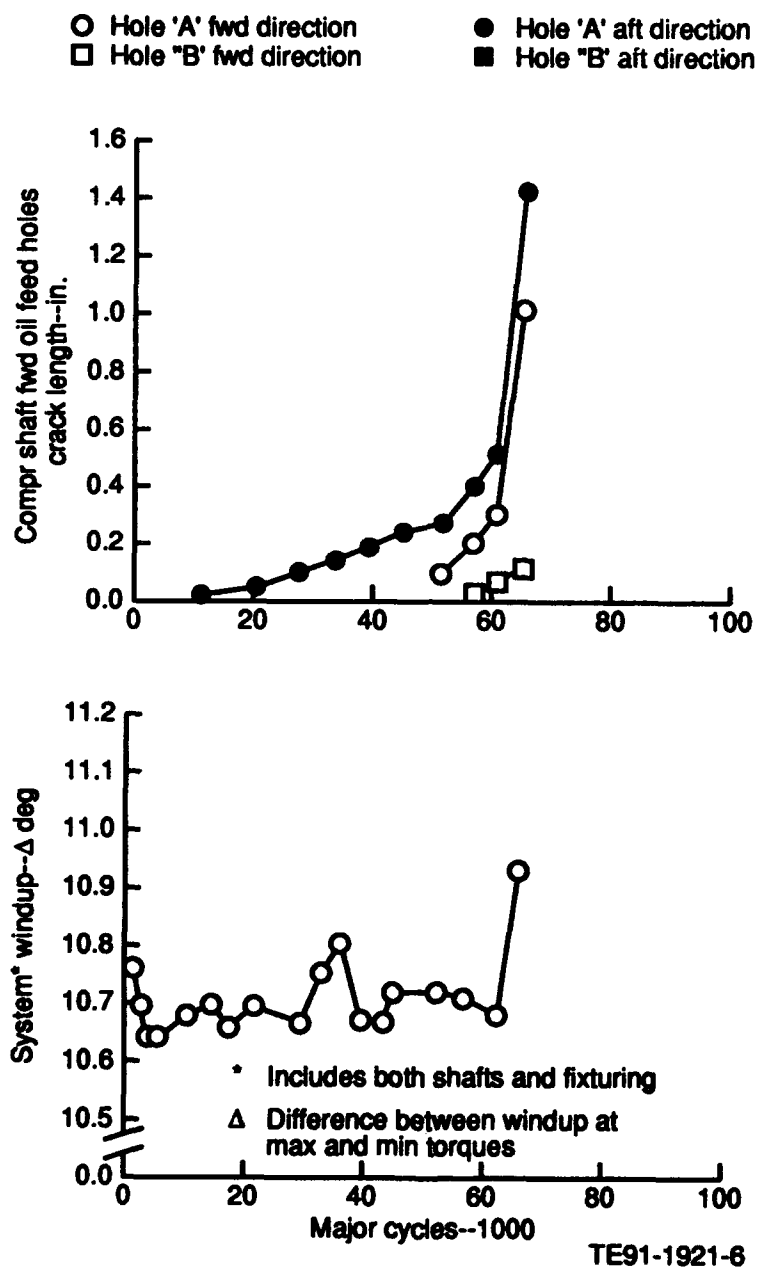
Fig. A-8. TF41 LP mainshaft LCF torsion (TC 875)—compressor shaft 6860005, DN 10033, N.B., 3760 hr; turbine shaft EX 147595, KK 13071, N.B., 0 hr, XA18268, BU 6.

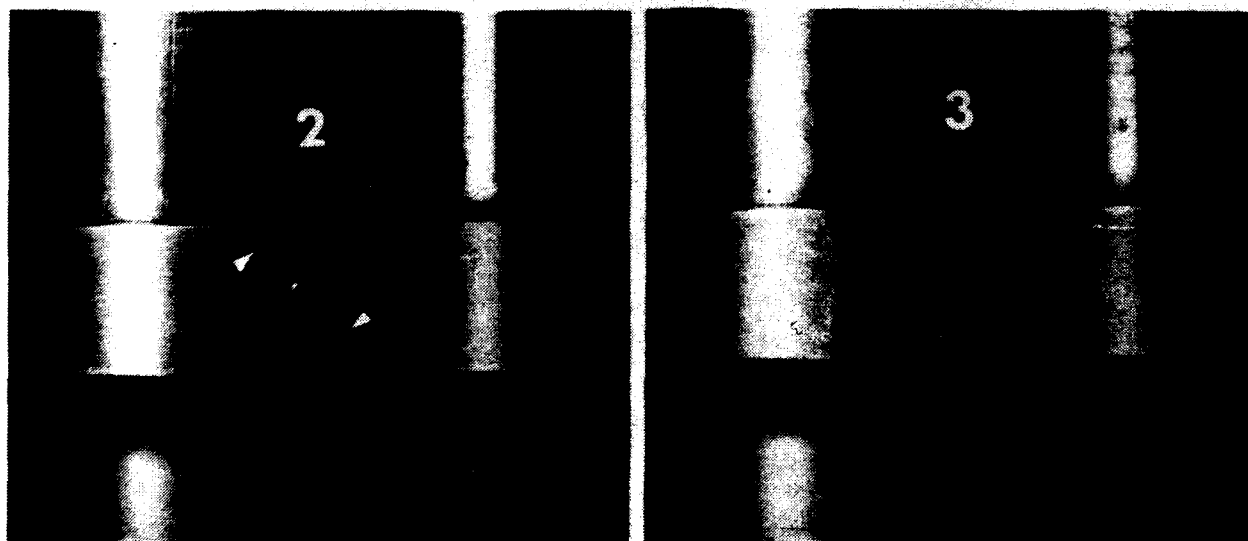
Figure 2. Blacklight photographs of the forward oil holes and associated cracks, indicated by arrowheads, on shaft A. Magn. 2X

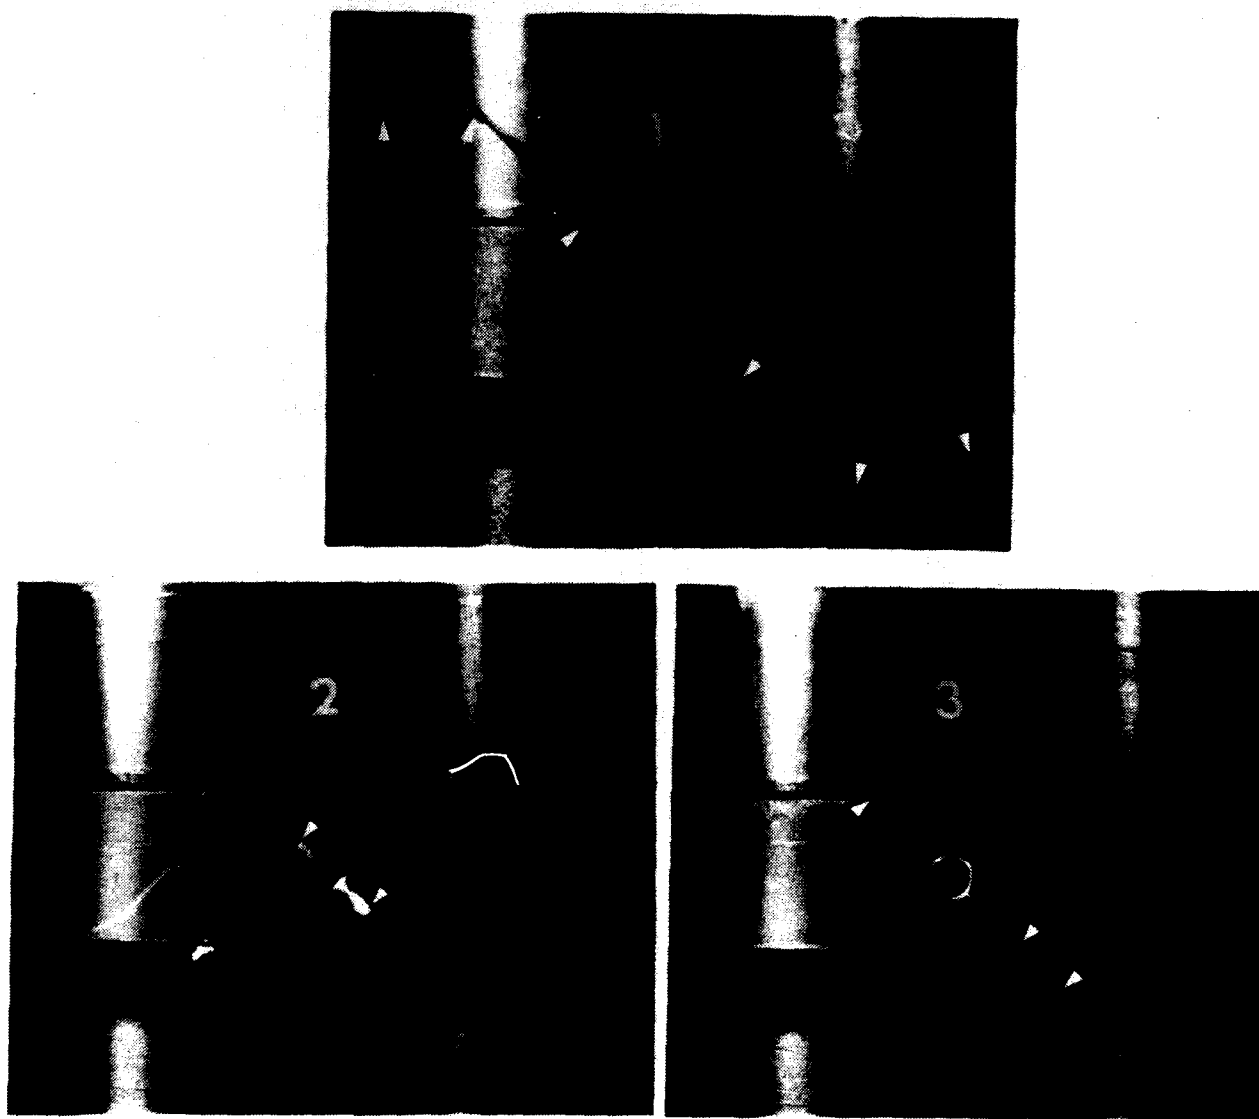
Figure 5. Blacklight photographs of the forward oil holes and associated cracks, indicated by arrowheads, on shaft B. Magn. 2X

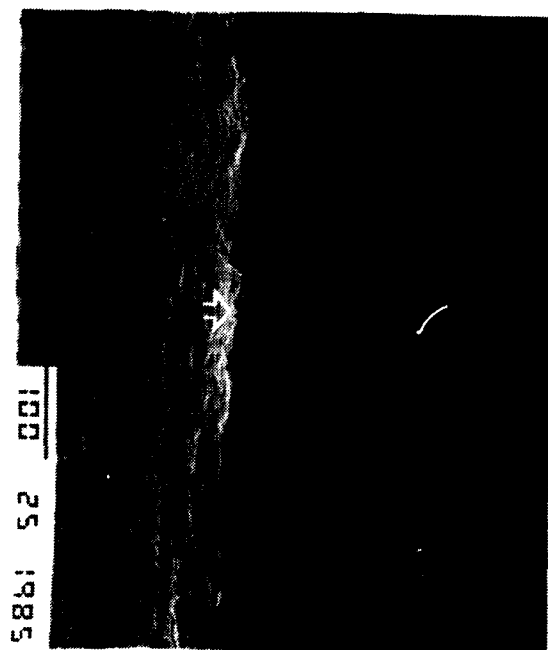
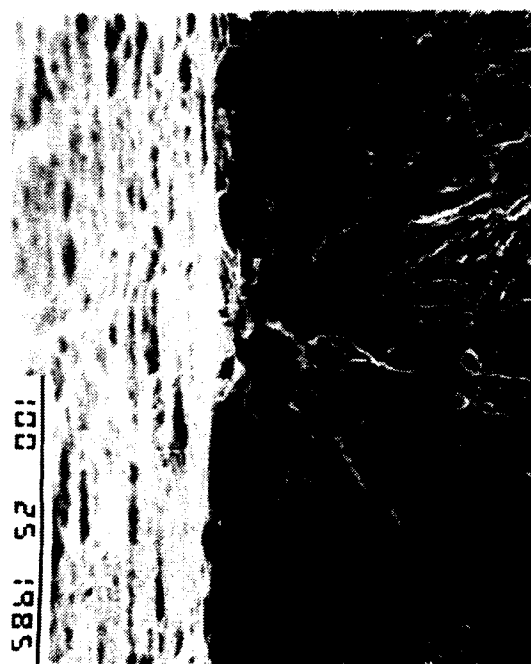
Figure 7. SEM photographs of the #1 fracture of shaft B.

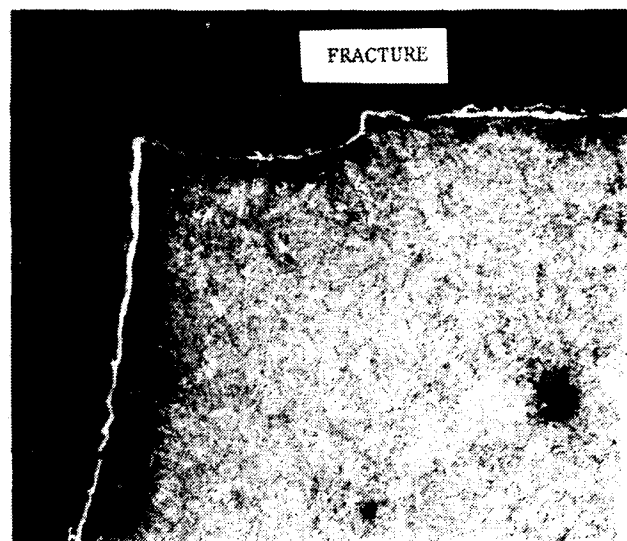
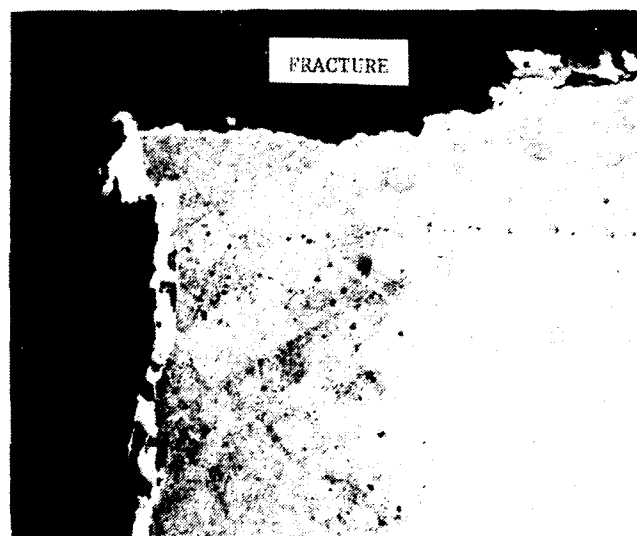
Figure 18. Micrographs of the fracture at the oil hole surface for the sections shown in Figures 4 and 8. Magn. 200X  
(Etchant: 5% Nital)

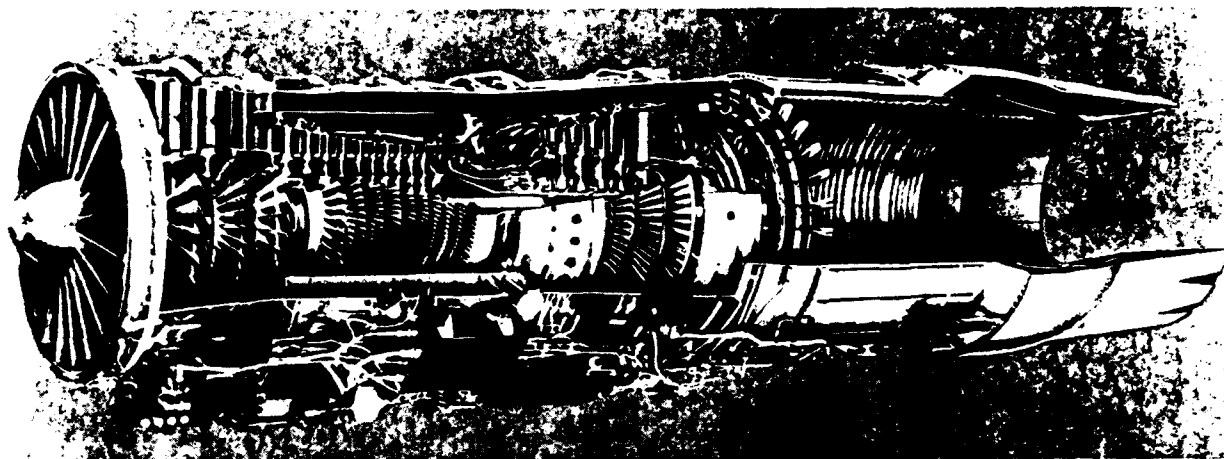
**Figure 1. F100 Engine Cross Section**

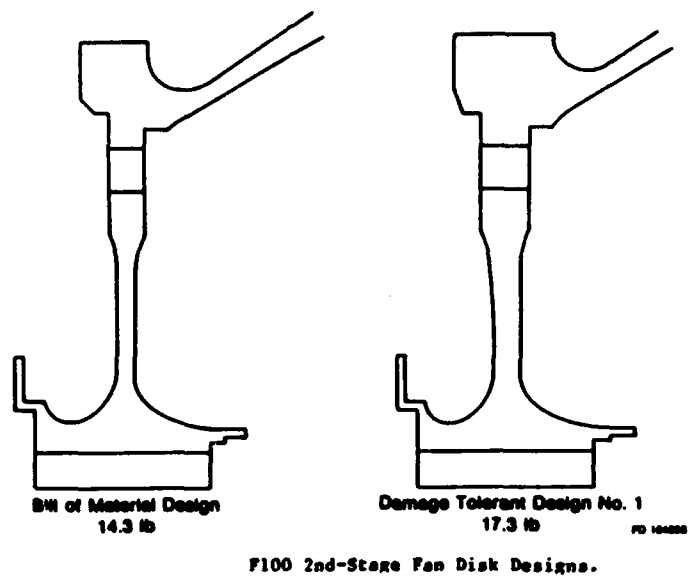
**Figure 3. Bill of Material Versus  
Damage Tolerant Design (DTD) Configuration**

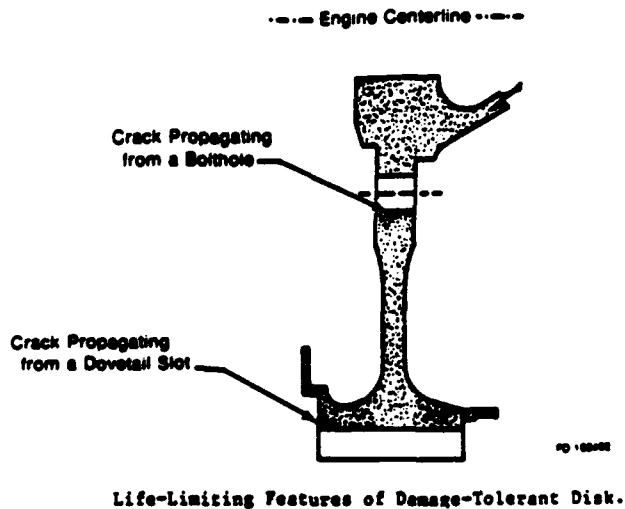
**Figure 4. Life Limiting Location On Damage Tolerant Disk**

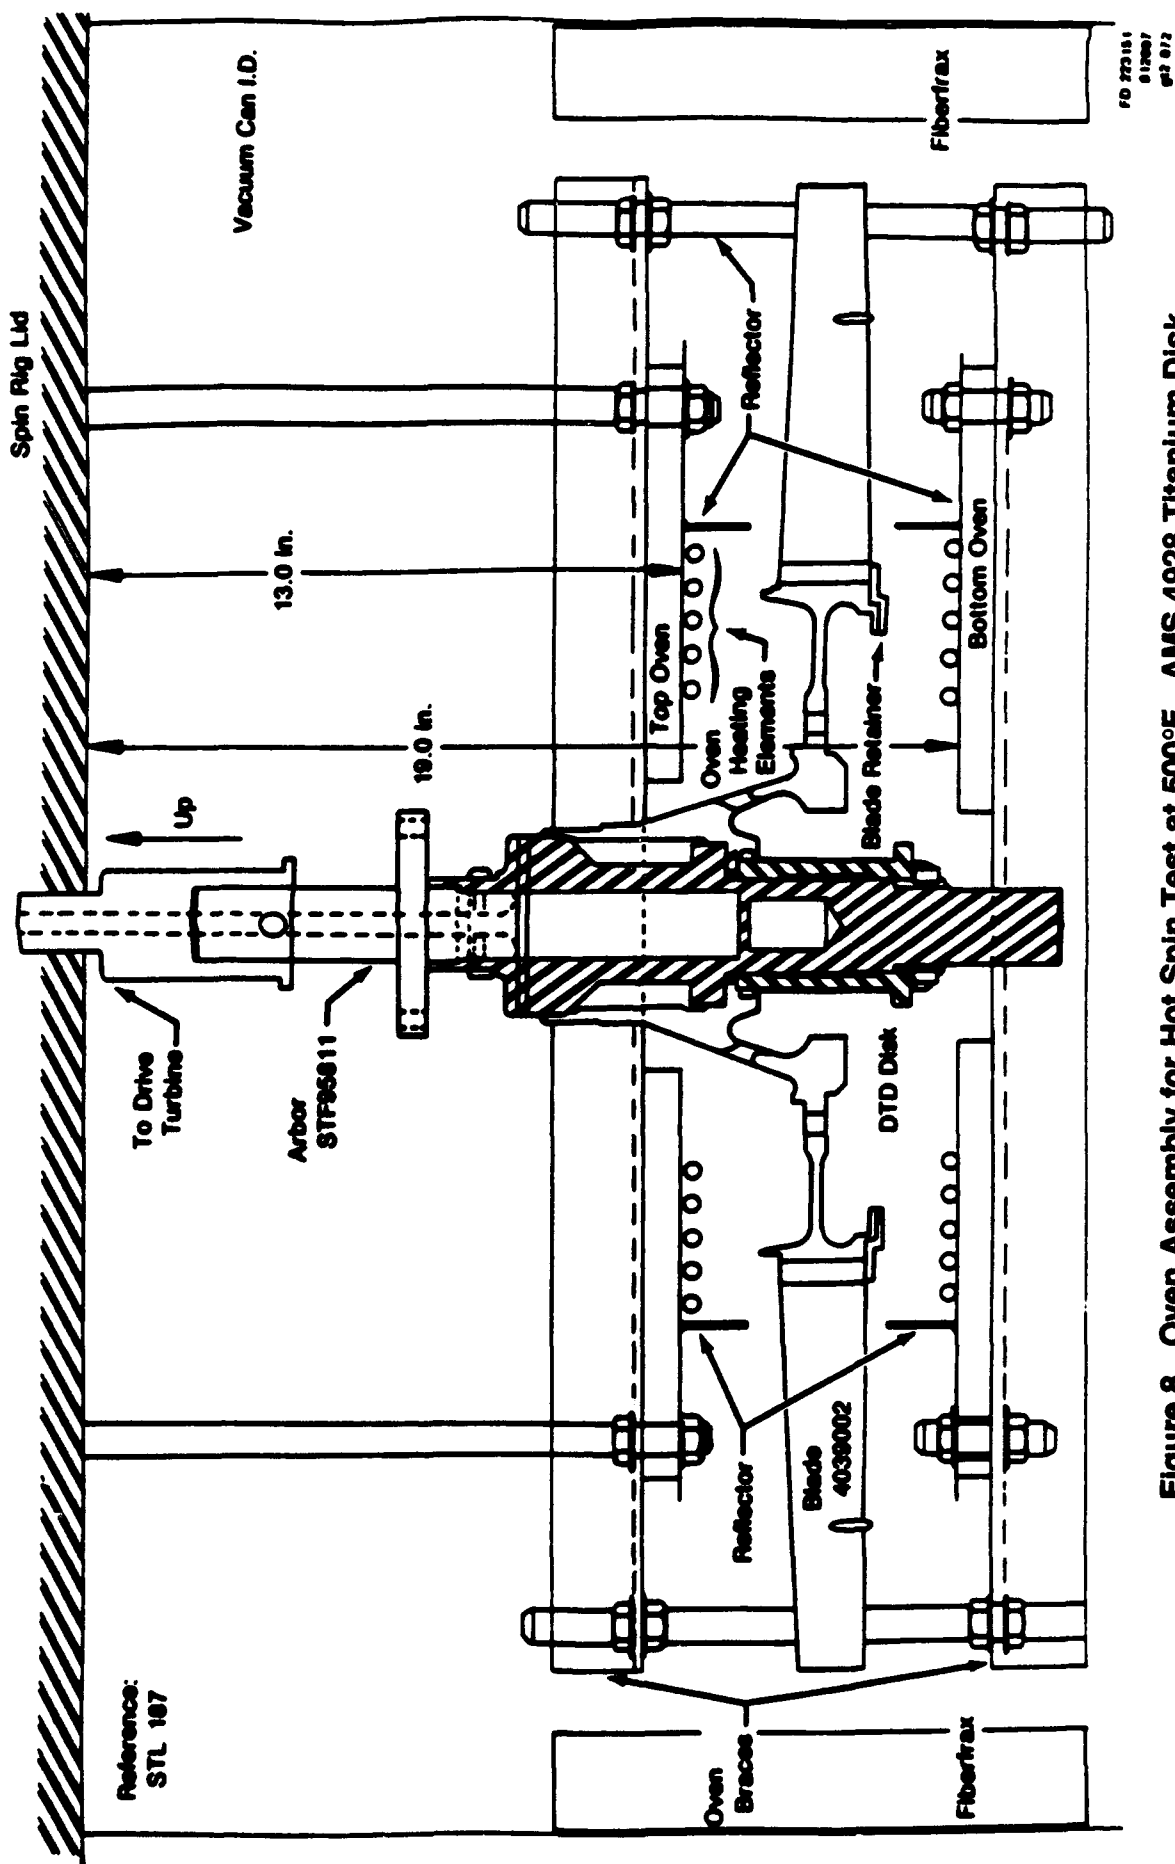
Figure 8. Oven Assembly for Hot Spin Test at 500°F. AMS 4928 Titanium Disk Derived From F100 2nd Stage Fan Design. Damage Tolerant Design Disk 1

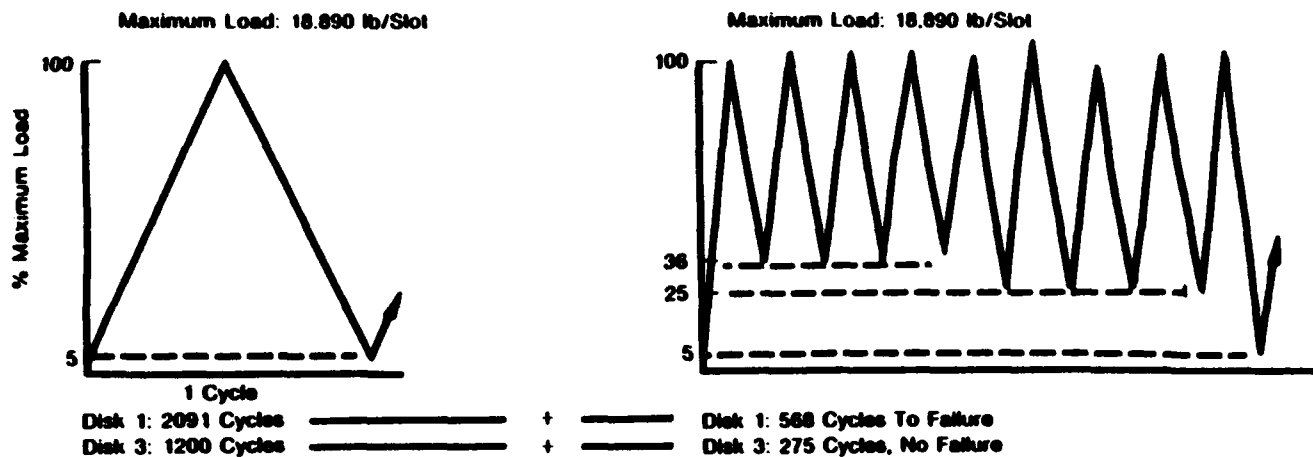
Figure 9. Load Cycle Definition for Ferris Wheel LCF Test

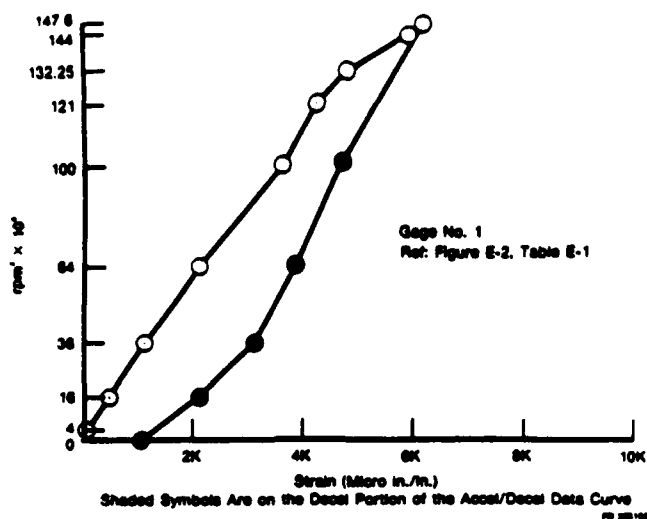
**Figure 25. RPM<sup>2</sup> vs Spin Strain Accel/Decel Data at 500°F to 12,150 RPM, Damage Tolerant Design Disk 1.**

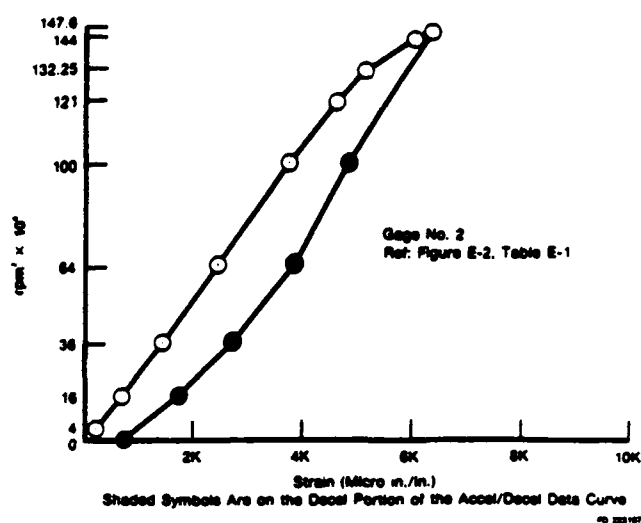
**Figure 26. RPM<sup>2</sup> vs Spin Strain Accel/Decel Data at 500°F to 12,150 RPM, Damage Tolerant Design Disk 1.**

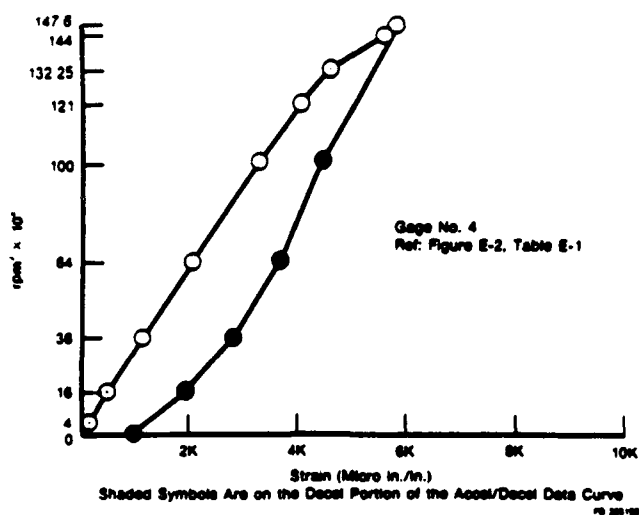
**Figure 27. RPM<sup>2</sup> vs Spin Strain Accel/Decel Data at 500°F to 12,150 RPM, Damage Tolerant Design Disk 1.**

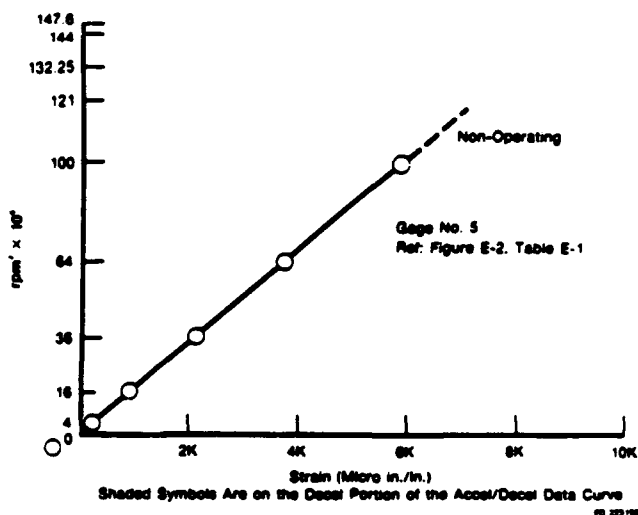
**Figure 28. RPM<sup>2</sup> vs Spin Strain Accel/Decel Data at 500°F to 12,150 RPM, Damage Tolerant Design Disk 1.**

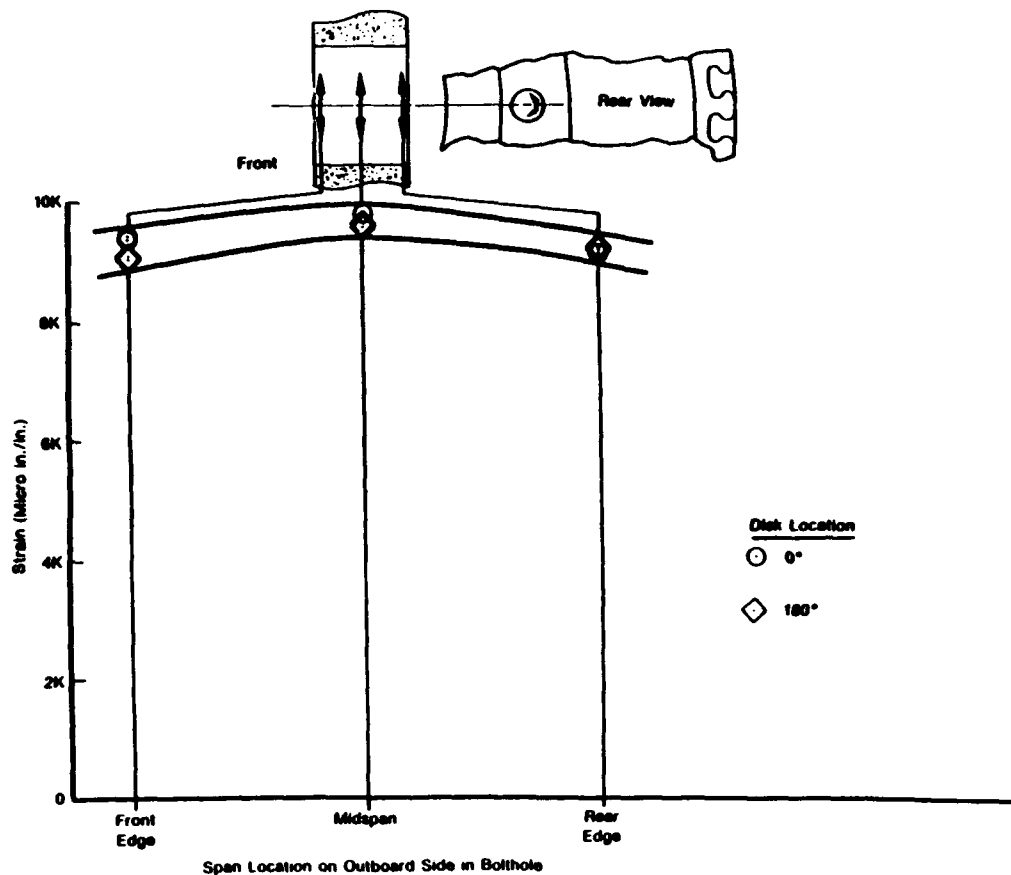
Figure 29. Static Strain Profile Outside Bolthole Edge. Room Temperature Ferris Wheel Test at 18,890 lb/slot. Damage Tolerant Design Disk 1. (Reference Figure 24 for Strain Gage Locations).

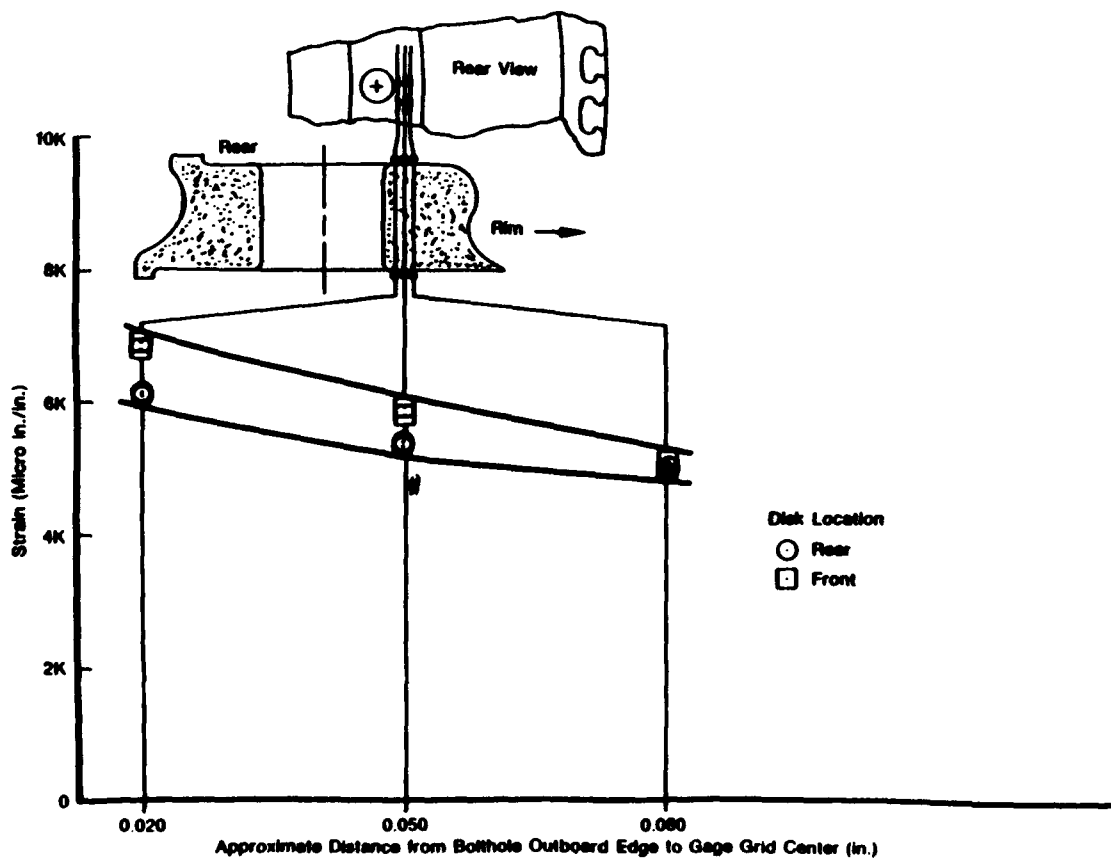
Figure 30. Static Strain Profile Outside Disk Bolthole Outboard Edge. Room Temperature Ferris Wheel Test at 18,890 lb/slot. Damage Tolerant Design Disk 1.

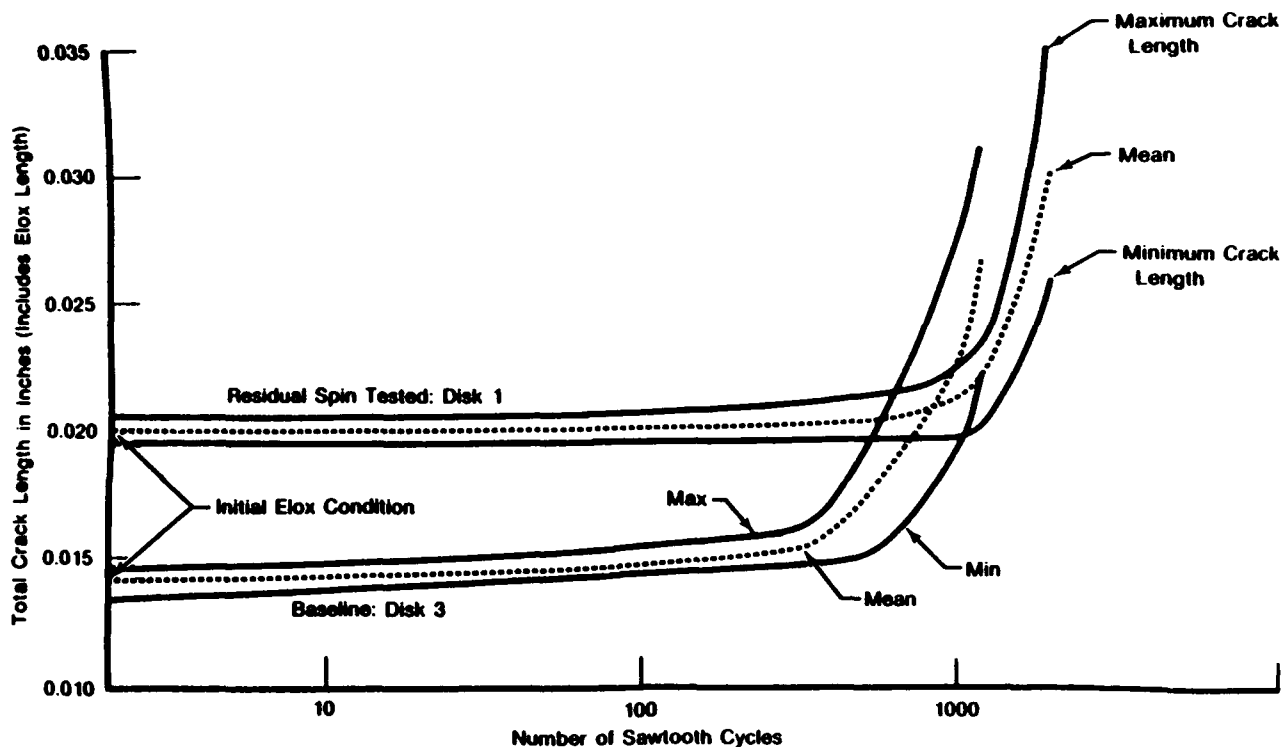
**Figure 33. Bolthole Crack Growth to 1/32 in. Initiation vs Ferris Wheel Sawtooth Cycles.**  
**Room Temperature Ferris Wheel LCF Test (Maximum Load at 18,890 lb/slot).**  
**Damage Tolerant Disk 1 and Baseline Disk 3 (Data Taken From Tables 8 and 9).**

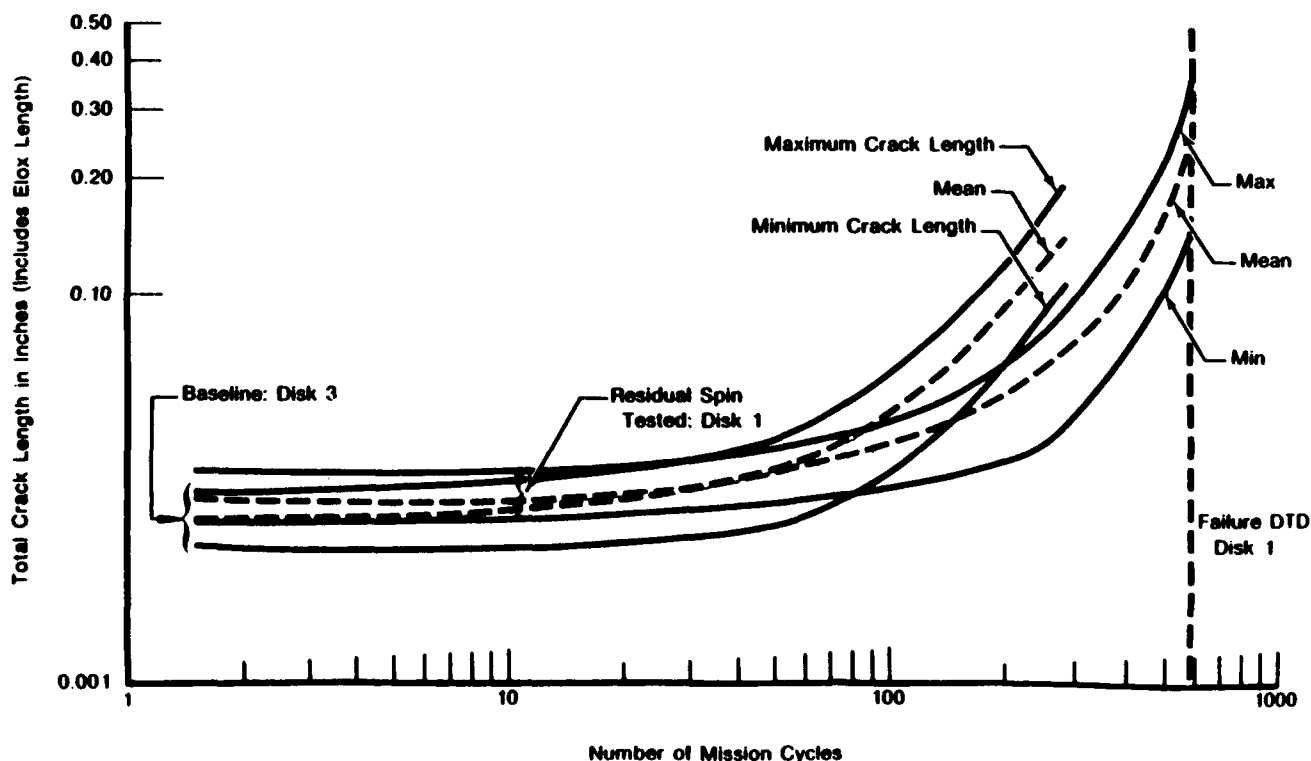
**Figure 34. Bolthole Crack Growth to 1/32 in. Initiation vs Ferris Wheel Mission Cycles.**  
**Room Temperature Ferris Wheel LCF Test**  
**(Maximum Load at 18,890 lb/slot) (Data Taken from Tables 8 and 9).**

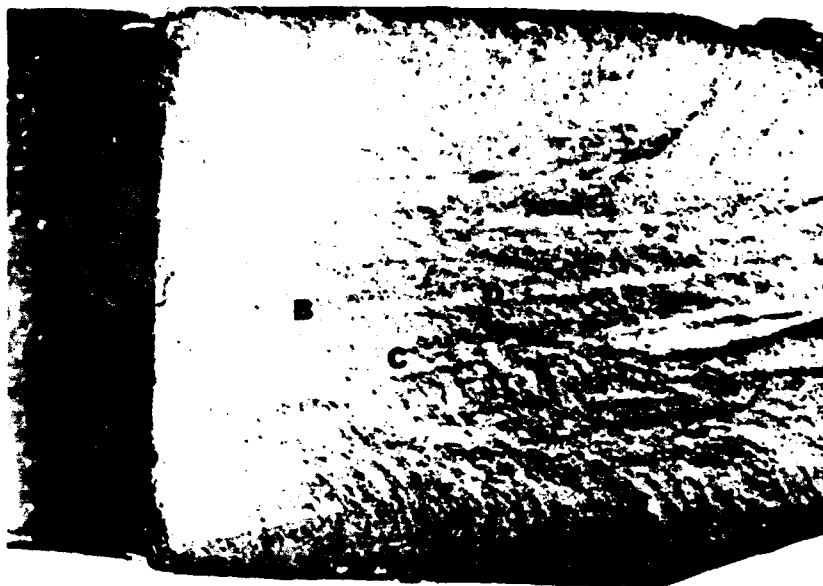
Region B: Located Same Distance From Elox Slot as Region A.  
This Area Shows Transgranular Fatigue With Well Defined Striations

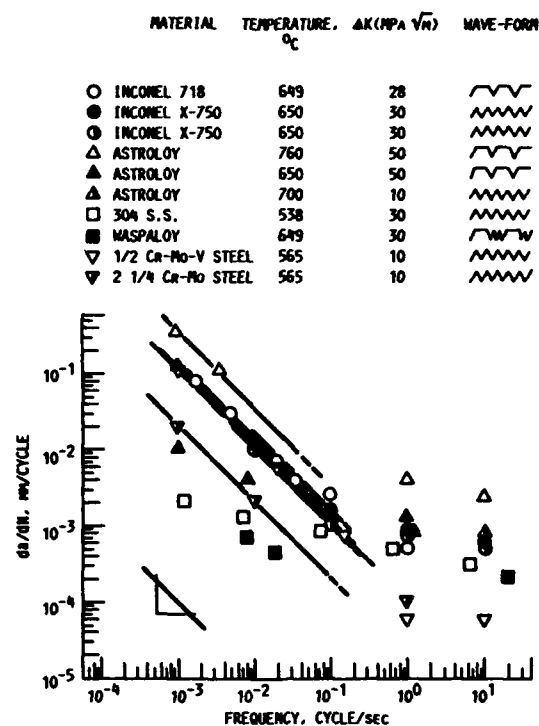
Fig. 1 Evaluation of the micro-mechanistic oxidation crack extension model of Liu and Oshida (7)
